Product Tech Bulletin Advisory

Affected Product: 679-SI-KIT Rev. C, Lucas L679 Installation

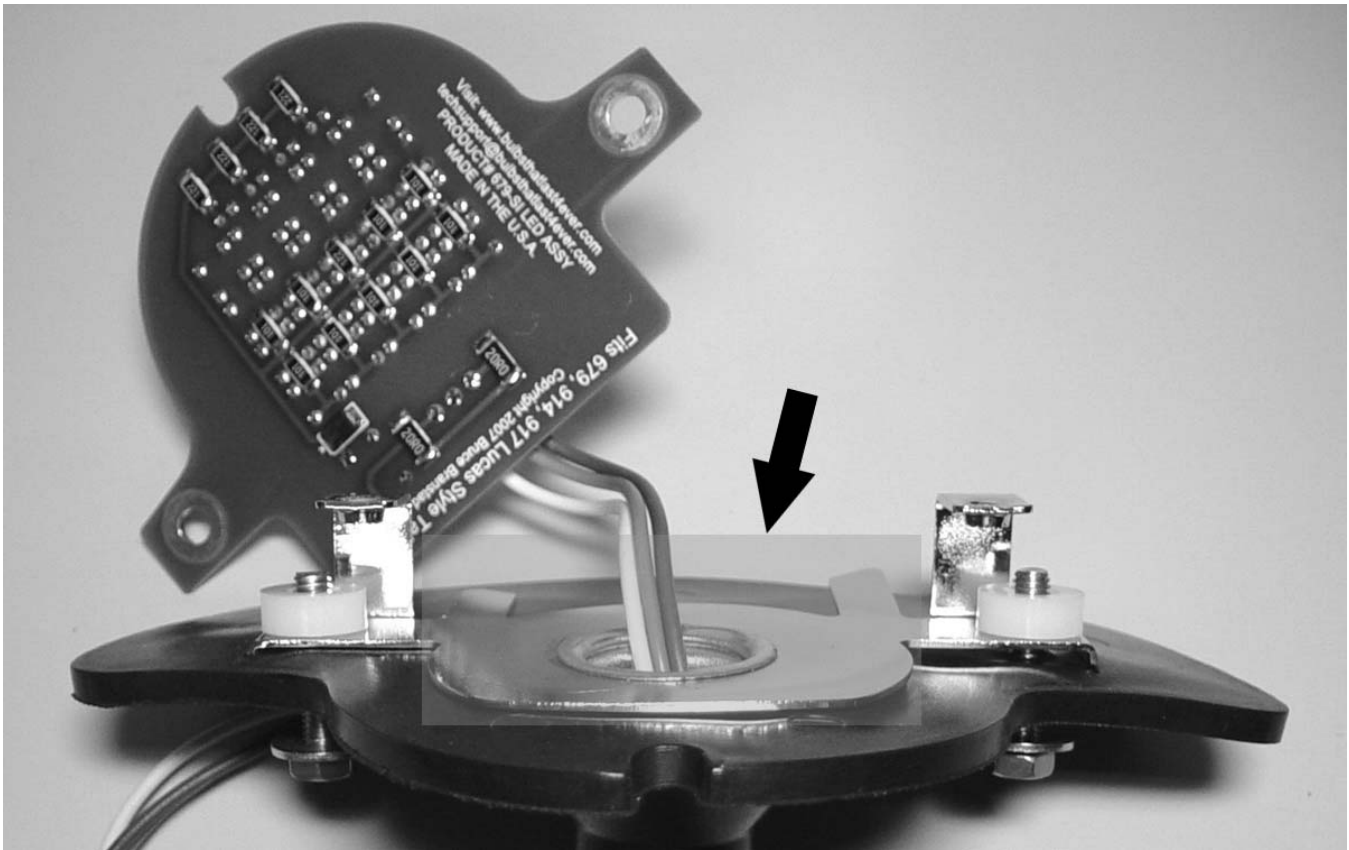
Issue Description: Back of LED Board coming into contact with taillight assembly bracket causing possible short-circuit condition to system ground, which could possibly cause damage to the LED Board. This could render the LED non-functional, which may cause unsafe condition.

Remedy: Apply vinyl electrical insulating tape to the mounting bracket's surface to cover all metal in the shaded area shown in the image below, to create an insulated safe-zone prior to installing the LED Board to the mounting bracket.
